# Manhole Inspection Summary

Manhole # S71U\_\_009MH

**Location** Address: **6929 Holabird Ave.**

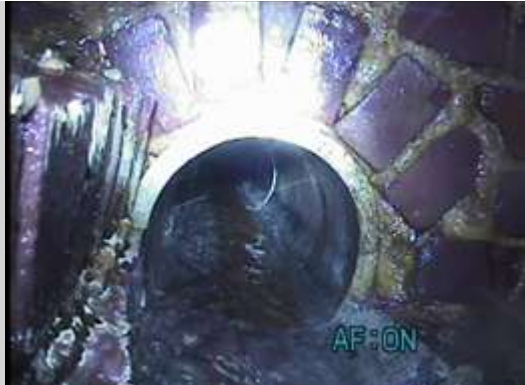
12 O'Clock Outflow

Pipe Height: **8.4** (in.) Rod and Bar (Angled)  
Pipe Material: **Clay** ☐ Pipe Lined  
Invert Depth: **11.13** (ft.) Flow Characteristics: **Fast**  
Deposits: ☒ None ☐ Mud ☐ Sludge ☐ Debris ☐ Grease  
Silt Depth: (in.) Deposits Extent:  
Infiltration: **None** Pipe Seal Cond: **Sound**

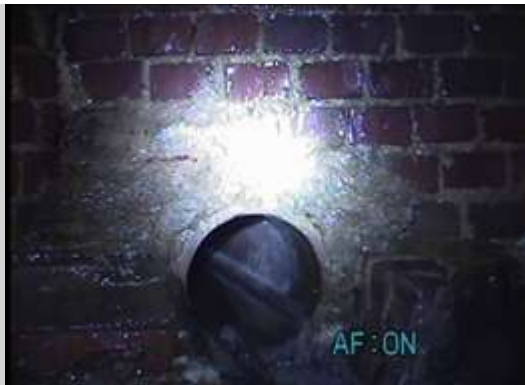
2 O'Clock Inflow

Pipe Height: **8.4** (in.) Rod and Bar (Angled)  
Pipe Material: **Clay** ☐ Pipe Lined  
Invert Depth: **11.00** (ft.) Flow Characteristics: **Slow**  
Deposits: ☒ None ☐ Mud ☐ Sludge ☐ Debris ☐ Grease  
Silt Depth: (in.) Deposits Extent:  
Infiltration: **None** Pipe Seal Cond: **Sound**
